APPENDIX 6-6

***BORD NA MONA DRAFT
PEATLAND
REHABILITATION PLANS***

Ballivor Bog

Cutaway Bog Decommissioning and Rehabilitation Plan

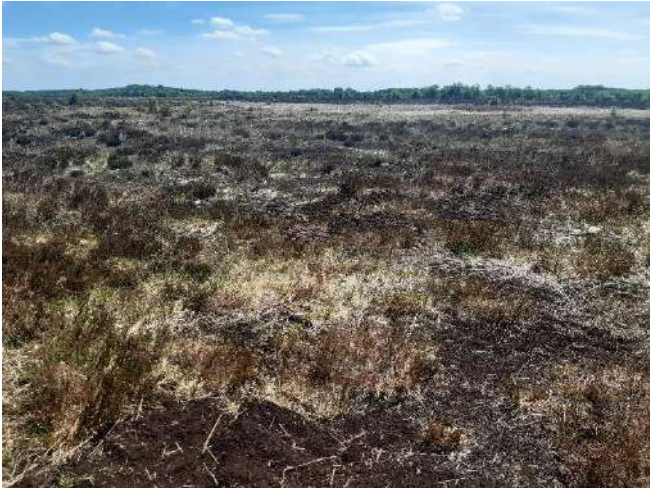
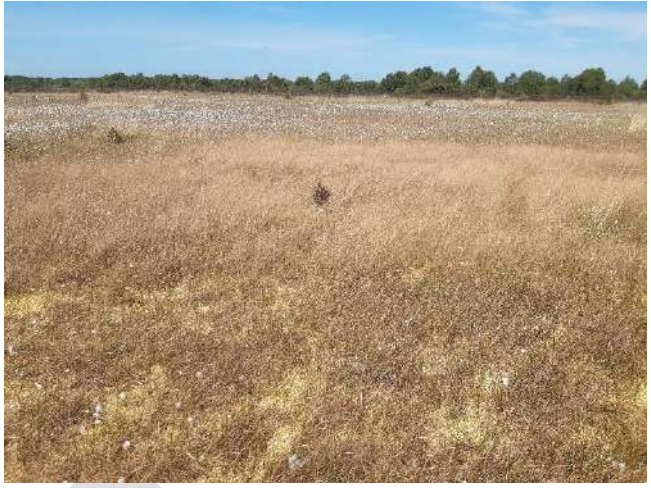
Table 1: Photos of Habitats at Ballivor Bog

<p><i>Bare peat and degraded bog habitat at Ballivor (May, 2020)</i></p>	<p><i>Bog cotton at Ballivor (May, 2020)</i></p>

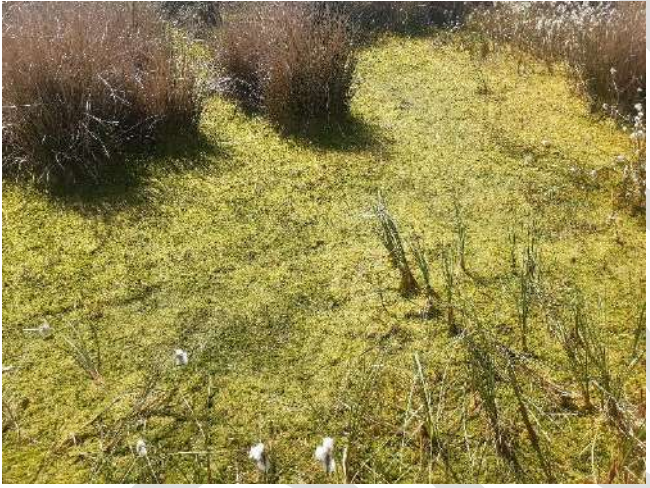
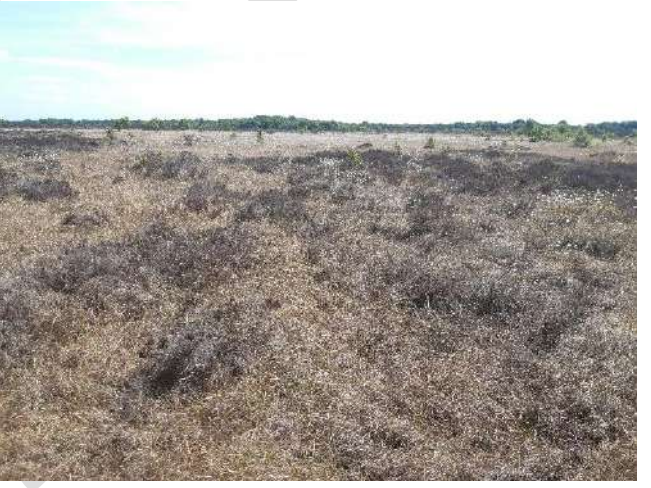
<p><i>Sphagnum at Ballivor bog (May, 2020)</i></p>	<p><i>Raised bog remnant at Ballivor Bog (May, 2020)</i></p>
